“PRACTICAL CASE STUDY”

Name of Work: - Re-Construction of Major High level Bridge across River **PAINGANGA** on Wadki - Wani – Antargaon – Gadchandur - Dewada State Highway No. 236 in Chandrapur District.

Name of Contractor: - CHAPHEKAR & COMPANY (J/V), NAGPUR

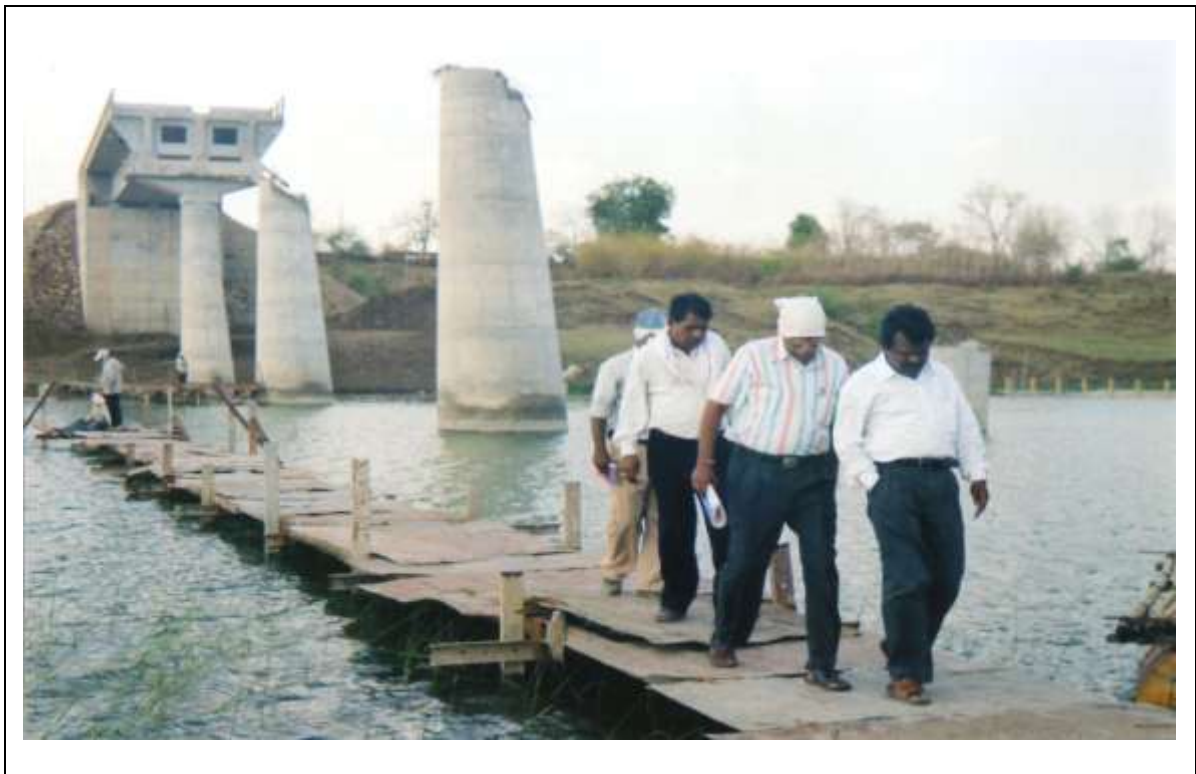
The old High level Bridge which was completed in March'2006 on this River at same location was washed away during the floods of July'2006 due to overtopping of the Bridge Super structure because of unprecedented rains in the catchment of the river. As such the Design HFL for which the Bridge was designed crossed its limits. Out of the 9 spans of 31 meter each, 7 central spans washed away to a distance of about 100 meters whereas the remaining 2 spans on either ends remained in slightly shifted position over the Pier Caps. A part of substructure at fixed level along with Pier Caps also washed away along with the super structure.

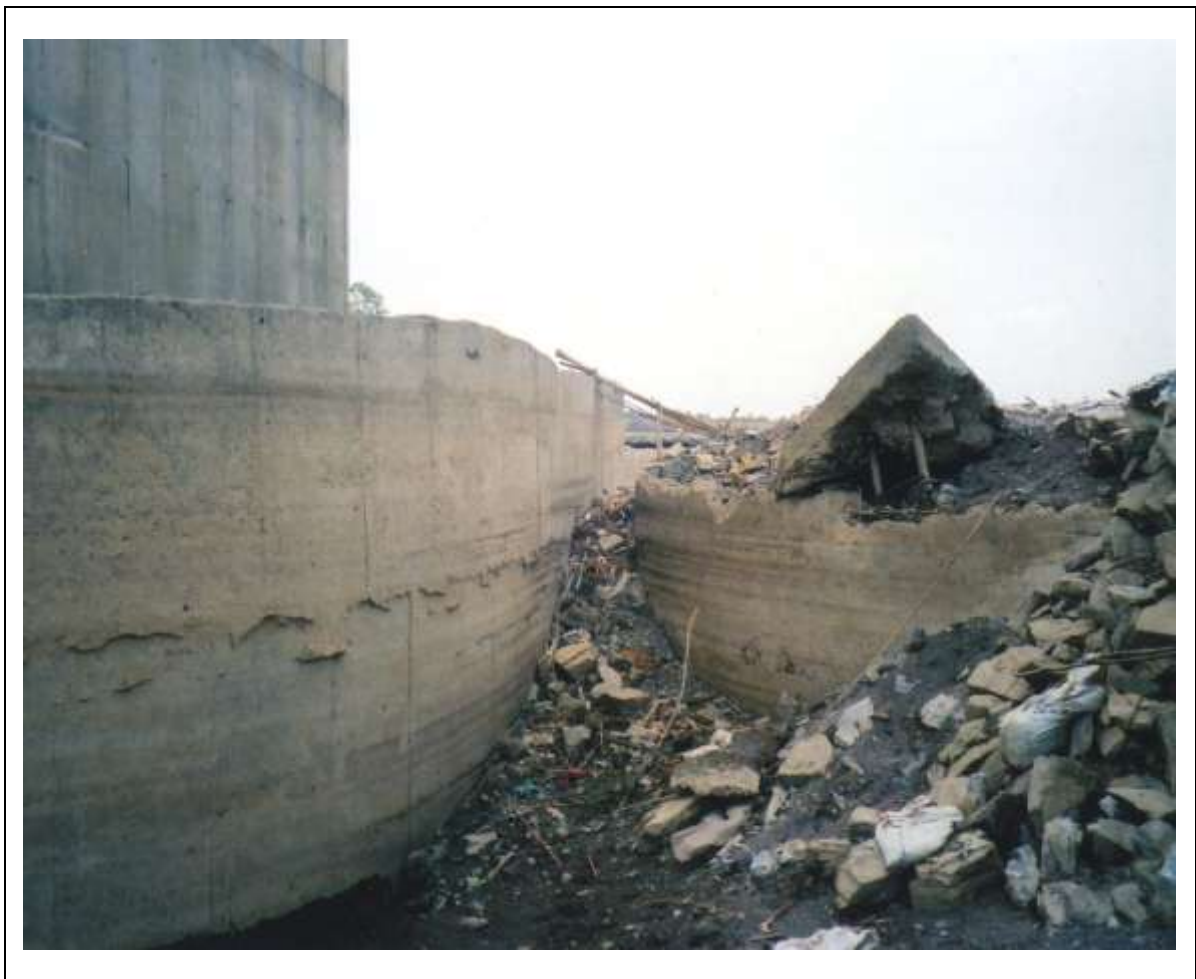
As the tender was called on lump sum basis i.e. on contractor's own design, we had to think of an out of the box alternative arrangement so as to be different from other agencies and to quote an economical and competitive offer. As such we proposed a combination of two different spans placed symmetrically along the length of bridge. While framing the proposal we were particular in taking into consideration the sizes of concrete cofferdams/ sacrificial wells of old bridge and having a clear margin of at least 0.5 m with them to cover up the shifting of cofferdams during execution of old work.

The major hurdle to be thought of at the time of tender submission of new Bridge was that the new structure was to be reconstructed at same location, with increased length and height, along the same alignment with partial remains in place of the old bridge Structure. At the time of tender submission we had to submit a Technical proposal with General Arrangement drawing showing the details of span length, Pier locations and type of sub structure with open foundations, etc. It was a challenge to

reduce the number of foundations by placing the Piers in such a way so as to avoid overlapping with the old foundation structures and their ancillary parts such as sacrificial wells, as it is not economical or feasible to dismantle remains of the old structure 2-3 meters below water. In the departmental drawing provided with the tender documents, Pier locations were shown exactly in between the positions of old structure.

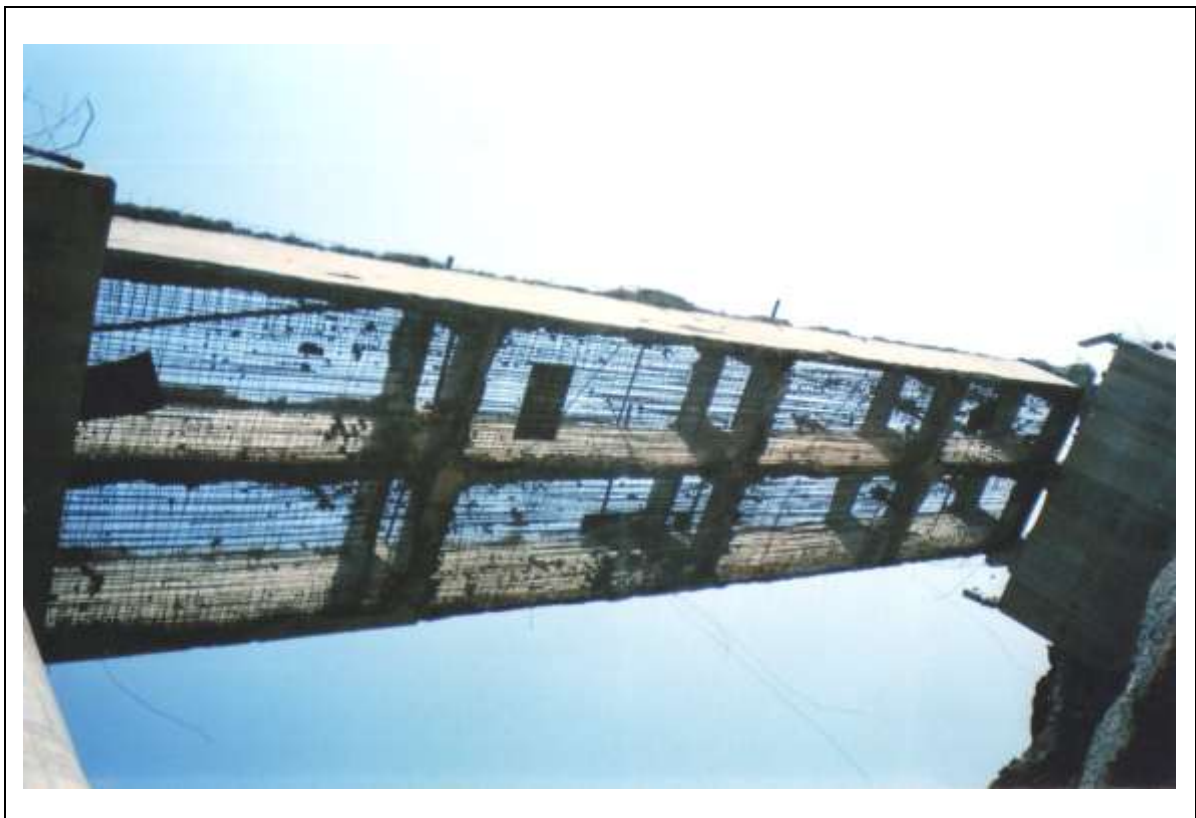
The first hurdle was to dismantle the RCC Box Girder by conventional equipments and avoiding use of expensive equipments such as concrete diamond cutters, etc. on a height of nearly 20 meters and to be within the stipulated time and cost. First the Deck slab was removed using heavy steel hammers and concrete breakers. The reinforcement was cut using gas cutters and all the girders were made free from compression flange. Similarly, the soffit slab was removed. Then by using a required charge of gelatins at the point of maximum bending moment, blast was carried out, as a result of which the girder completely collapsed below on the river bed at the very location without damaging the adjoining old structure. It was then removed from the riverbed in pieces using concrete breakers.

In old structure, there were 6 nos. hollow circular piers with 12-15 meter of their height in tact with concrete sacrificial wells, below riverbed level, cast during the foundation work. There were 2 nos. RCC Box Girder type spans of 31 meter length at a height of 20 meters.

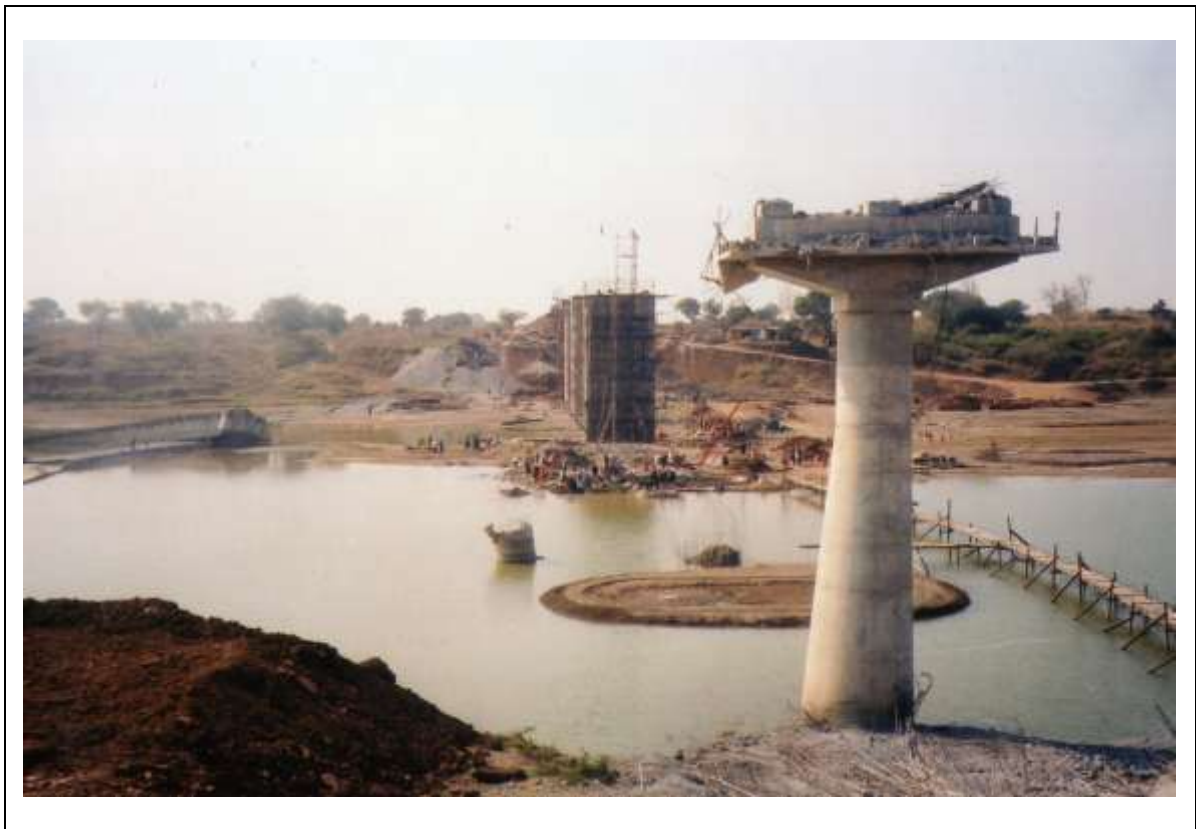
The second hurdle was in the form of hollow circular Piers, which were also to be dismantled up to bed level. These were also dismantled using a combination of hammers, concrete breaker and blasting. As the piers were hollow circular in nature, scaffolding has to be erected from all the sides to enable the workers to stand on the platforms for operating the breakers and other equipments. While making holes for blasting, care was taken to have at least one hole in the wall thickness and other hole a bit staggered at a distance of 0.3 m along the periphery.

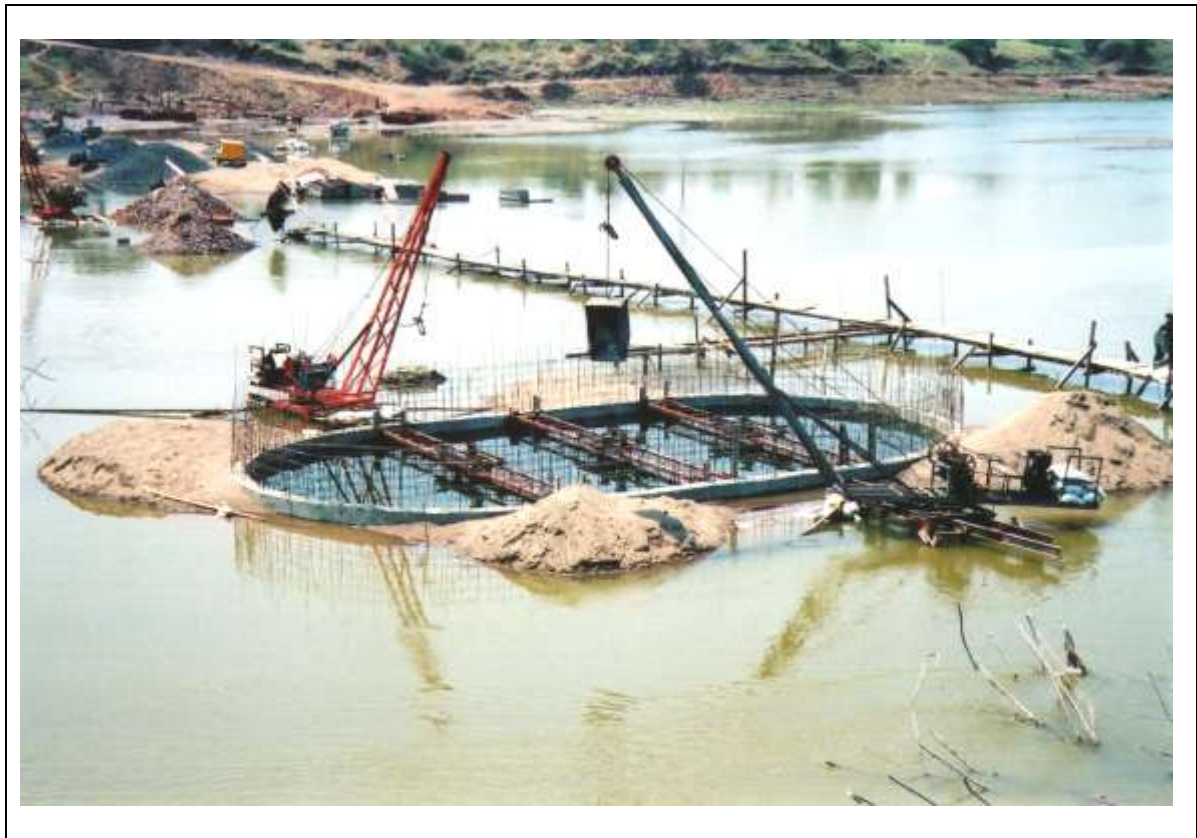
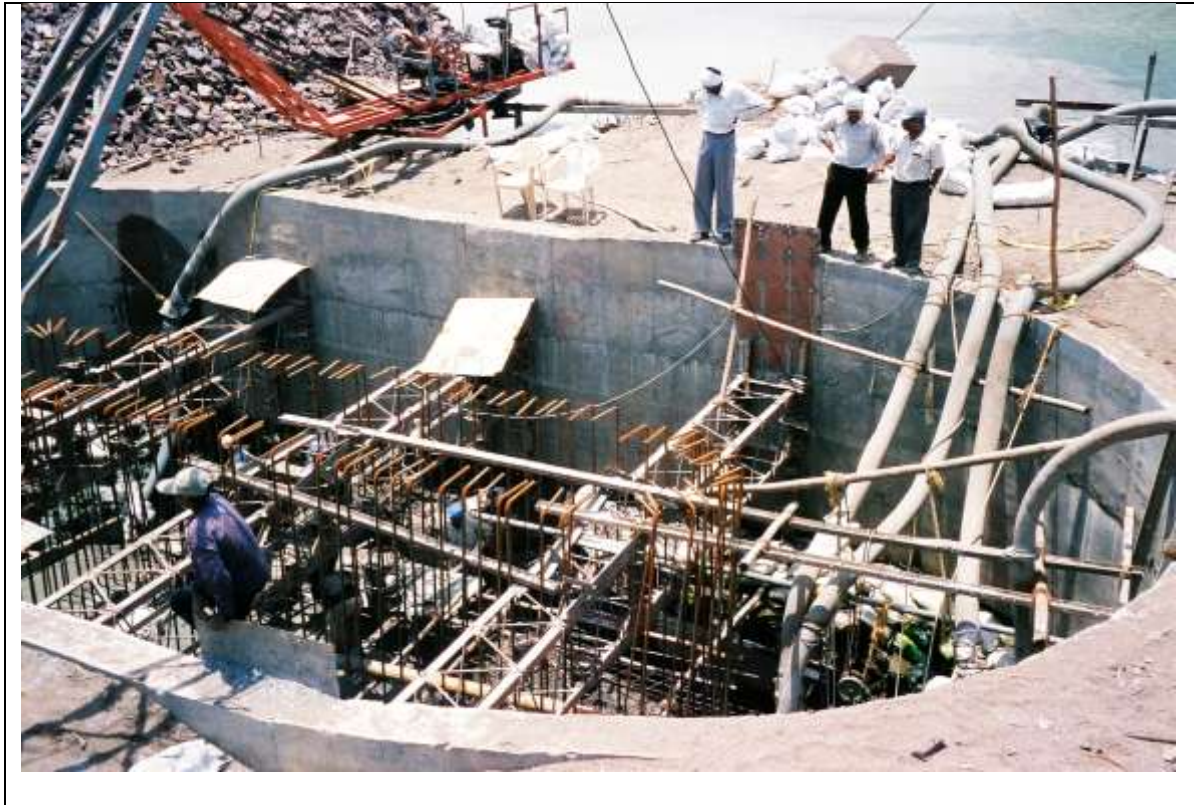
The third hurdle, which we have already put forth in the starting paragraphs, was to avoid the overlapping of old bridge foundations and their ancillary structures such as concrete cofferdams/sacrificial wells. As structures were below bed level and further below lowest water level throughout the working season, it is very difficult or can be termed as “near impossible” task to break these structures, in case they had overlapped, by using conventional dismantling equipments within stipulated time and lump sum cost. Generally, the sacrificial wells are circular in shape due to ability of such section to sustain more compressive pressures from outside. For this work, we had to go for double D shaped concrete cofferdams, instead of regular circular, for excavation in sand for foundation activities. Because of this we could avoid the

overlapping with the old cofferdams at some locations. In such type of cofferdams the only draw back is that the walls are to be supported by temporary structural arrangement from inside to avoid their failures due to lateral buckling in presence of saturated sand from all sides.

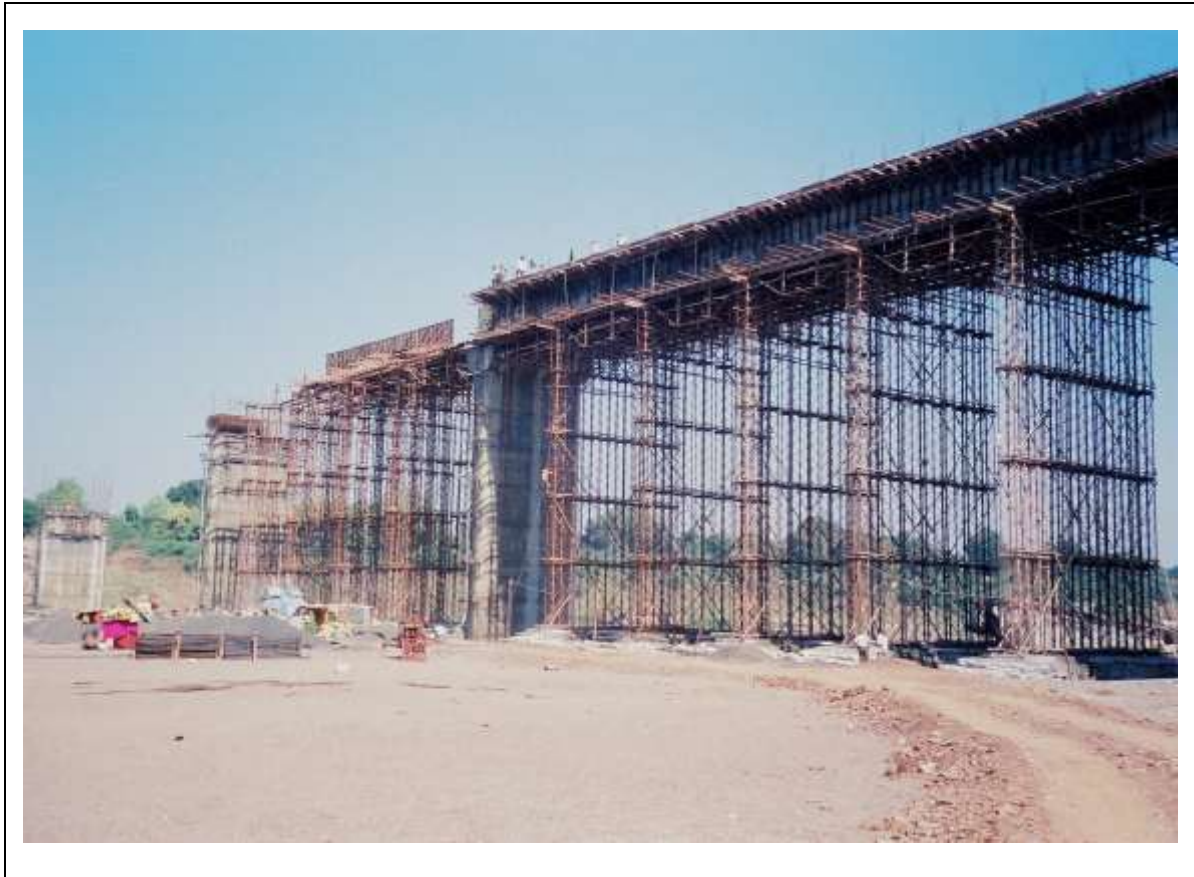
As the super structure was Post Tensioned Box Girder type and was proposed to be cast in situ over the POT-PTFE bearings placed over the Pedestals, staging arrangement was done from the bed level to the soffit level of the span. As per our centering arrangement, the column supports were at every 8 meter distance and as such dead load and construction live load reactions were sufficiently high. For this specially designed trestles/ steel columns were erected over concrete foundations, which in turn are supported over rubble masonry. As an additional precaution, timber/balli piles were also provided below this concrete foundation to avoid any settlement due to flowing of river sand below the bed level. These balli piles of 100 mm to 125 mm diameter were driven till refusal i.e. at least 6-7 meter below the bed level and its top tips were inserted in the doubly reinforced column foundation concrete. On an average 5 numbers of piles are provided below each column.

Construction of Cast in situ Super structure:

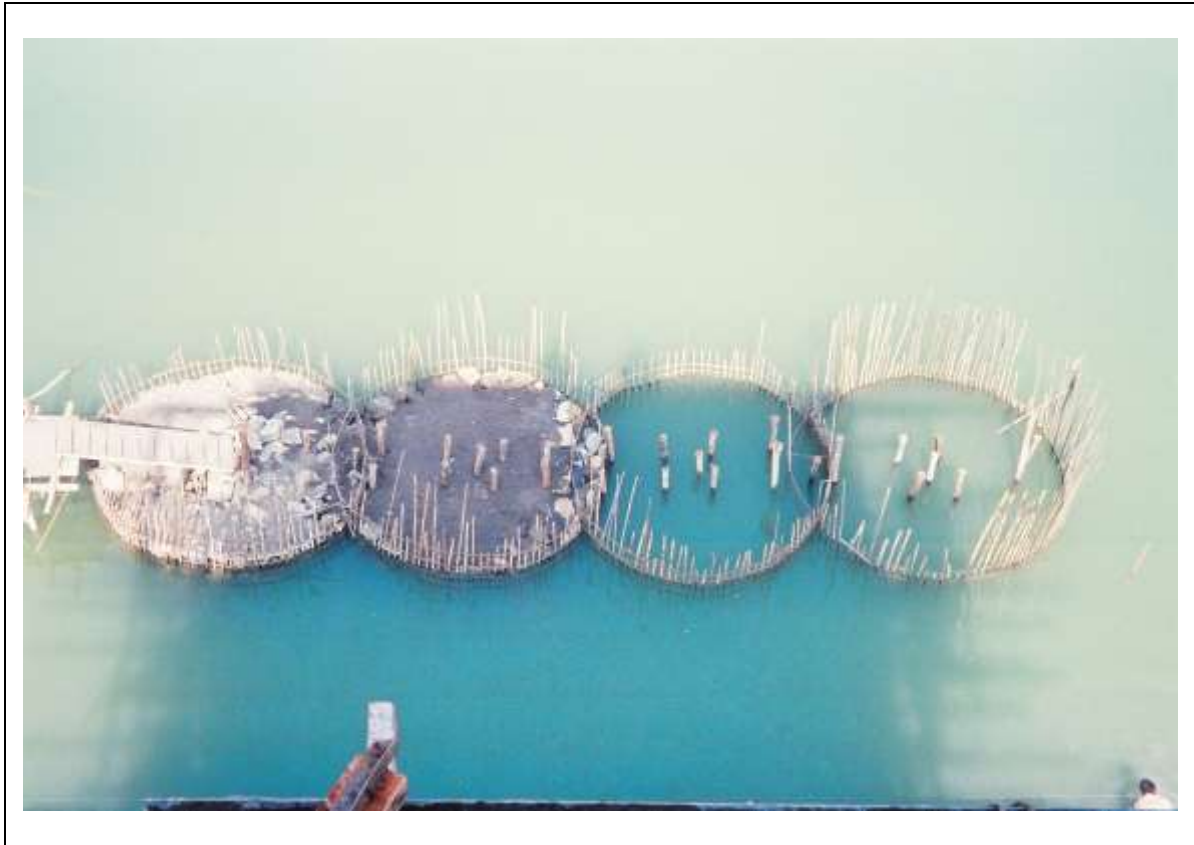
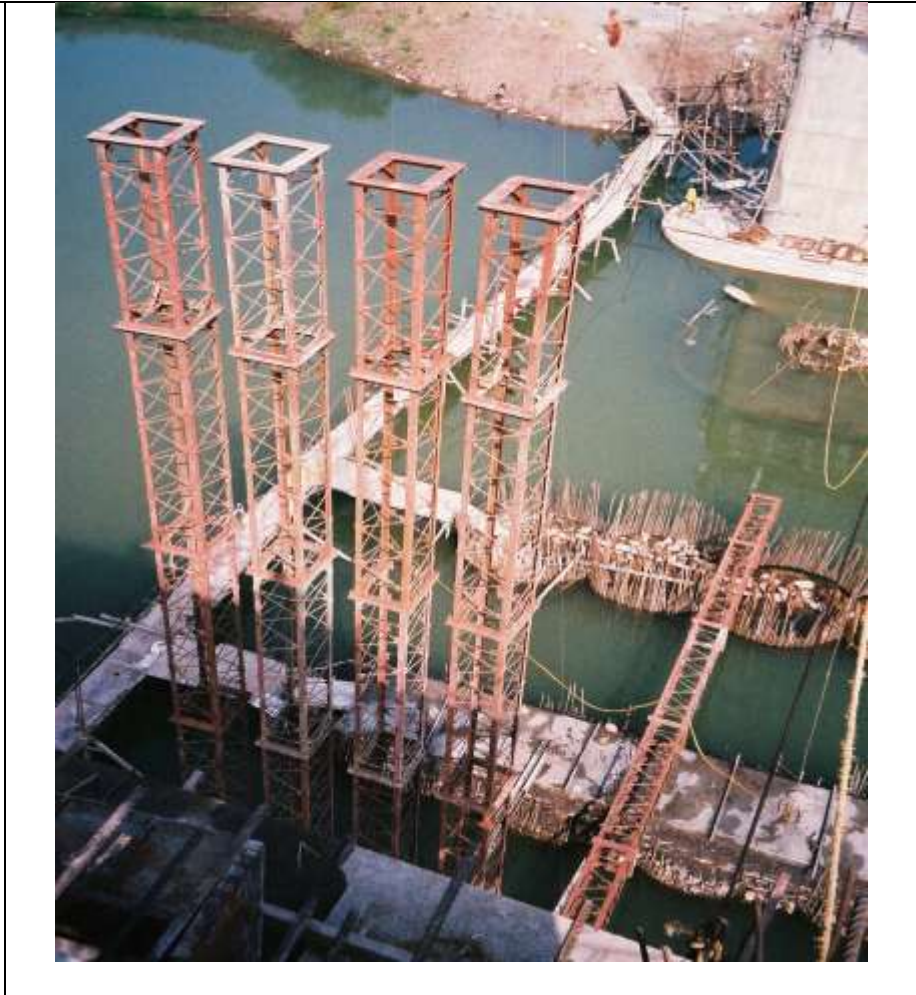
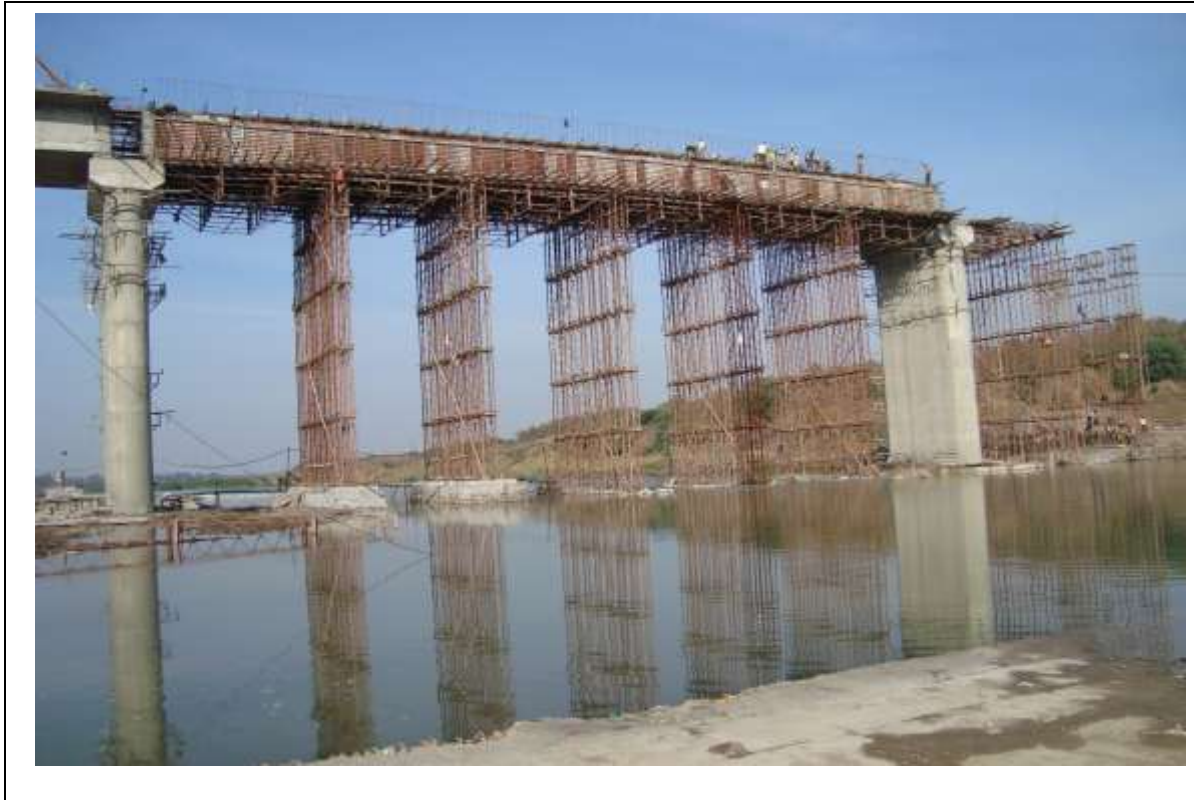
Similar arrangement as mentioned above was also made for the span where the water flows throughout the season. The only difference was protection of rubble from flowing water and to avoid scour. Instead of the masonry directly on the sandy bed, cage islands were provided. The cages are made from steel bars welded together in the form of vertical bars and rings. The rings are further tied with closely spaced vertical bamboos and covered with bamboo mats, to retain the rubble filled in between them. The voids in the rubble filling after placing in these rings are further filled with dry mortar. To achieve the strength remaining voids are filled by cement grout injected by compressor.

Staging arrangement for Cast in situ Super structure in flowing water:
